Errata: CS43L43 Rev. DCS43L43 Low Voltage, Stereo DAC with Headphone Amp

All references to the CS43L43 mentioned below shall be taken to refer to revision D of the CS43L43 product. The hardware revision code can be found in the 10-character field printed below the part number on each chip. The letter which appears as the fifth character from the right is the revision code (e.g. ZNACSD9926 is a Revision D part).

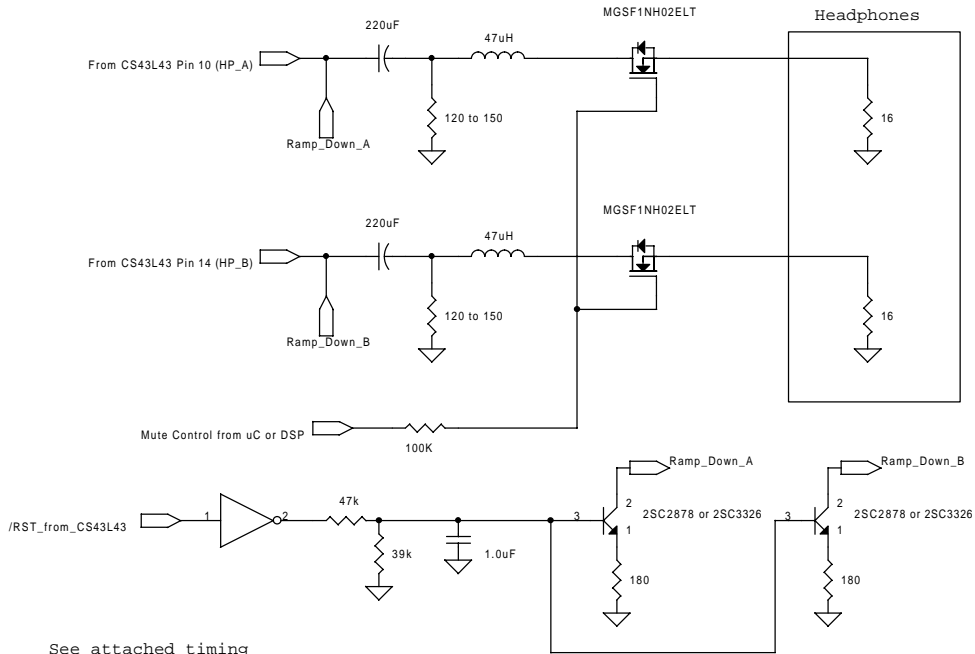
Figure 1. Pop Guard Fix

- The PopGuard[®] Transient Control does not function properly and will produce audible artifacts on the headphone outputs during power-up. A hardware fix is available for this issue and is shown in Figures 1 and 2.

- The PopGuard[®] Transient Control power-down ramp requires 5 seconds to prevent audible artifacts on the headphone outputs at the next power-up. A hardware fix is available for this issue, see Figures 1 and 2 for details. This fix will reduce the ramp down time to approximately 300 milliseconds.

The Motorola MOSFETs shown have been tested to work properly, however, an equivalent device may be used.

The Toshiba transistors or equivalent will work best here. The device used must have a very low R_{on} (3 ohms or less).

See attached timing diagram for /RST and the Mute control. Customer will need to generate the mute control from their DSP or micro-controller.

2SC2878 is in TO-92 package
2SC3326 is in SOT-23 package
