# **3 VOLT FlashFile™ MEMORY**

## **28F004S3, 28F008S3, 28F016S3**

### **SPECIFICATION UPDATE**

Order Number: 297799-009

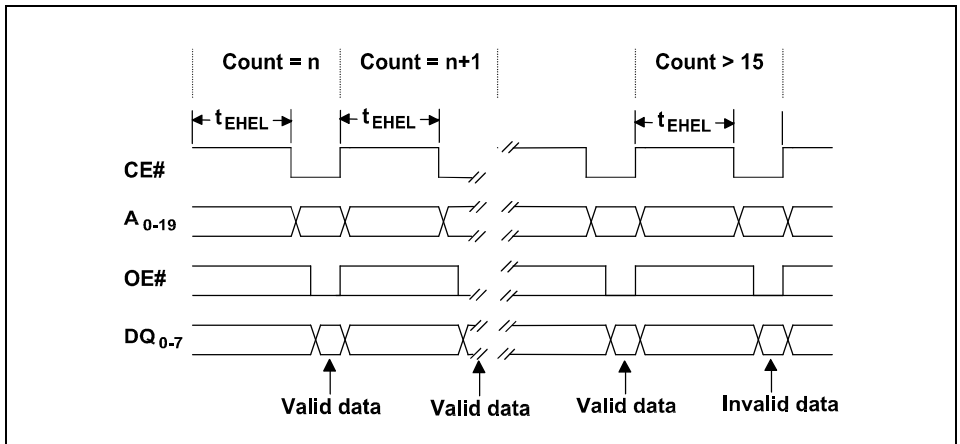
**PROBLEM:** The component may return invalid data if more than fifteen successive read operations are performed where CE# is deasserted between each read and the corresponding CE#-high pulse width resides within the specifications outlined in the table below.

**Successive Read Operations That Have Long CE#-High Pulse Widths**

**IMPLICATION:** If it is determined that CE#-high time violations occur, carefully examine subsequent reads. If the ratio of good to bad (CE#-high times within the specifications outlined in the table above) reads is high, your system may not have a problem. For every bad read the system performs, five good reads for A-1 and A-3 stepping and two good reads for A-6 stepping are needed to cancel the effect of the bad read. So, carefully analyze the flash memory CE# input to understand the CE#-high characteristic.

1. Read more than four good reads for A-1 and A-3 stepping and only one read for A-6 stepping during each assertion of CE#, as illustrated in the figure above.
2. Issue a Byte Write command and program FFh to any location before executing a read operation. Programming FFh will not alter stored data, but it will give the component sufficient time to prepare for the read operation.

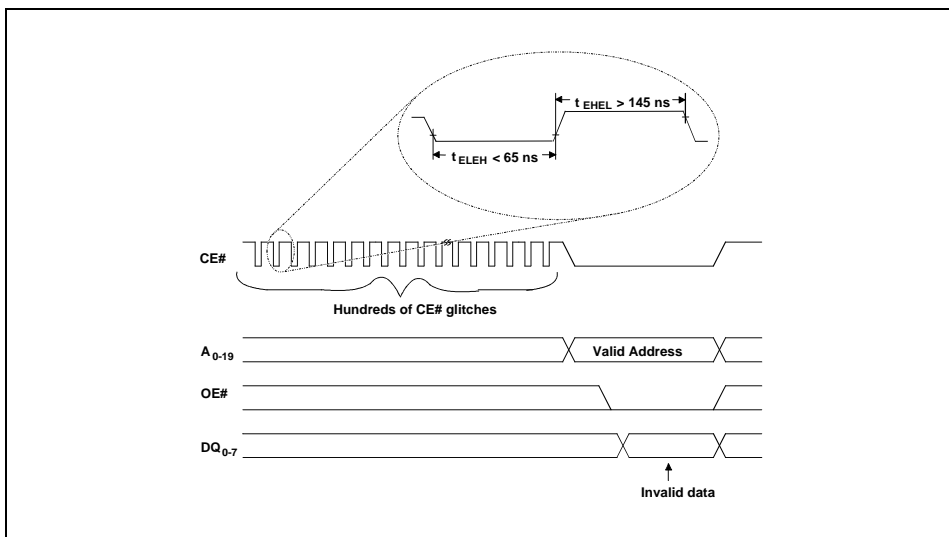
**PROBLEM:** A noisy CE# control signal may cause an invalid read. This erroneous read only occurs after the device has received over one hundred consecutive short CE# glitches ( $t_{EHL} < 65$  ns) with CE#-high time ( $t_{EHL}$ ) greater than 145 ns (see the figure below, *A Long Series of CE# Glitches May Induce an Invalid Read*).

**A Long Series of CE# Glitches May Induce an Invalid Read**

After valid data is read, the device must receive another series of CE# glitches (typically over one hundred) to induce an invalid read.

Add system logic to prevent CE# glitches such as latched CE# control logic or pullup/pulldown resistors to the address bus.

If the device receives over one hundred consecutive CE# glitches, issue a Byte Write command and program FFh to any location before executing a read operation. Programming FFh will not alter stored data, but it will give the component sufficient time to prepare for the read operation.

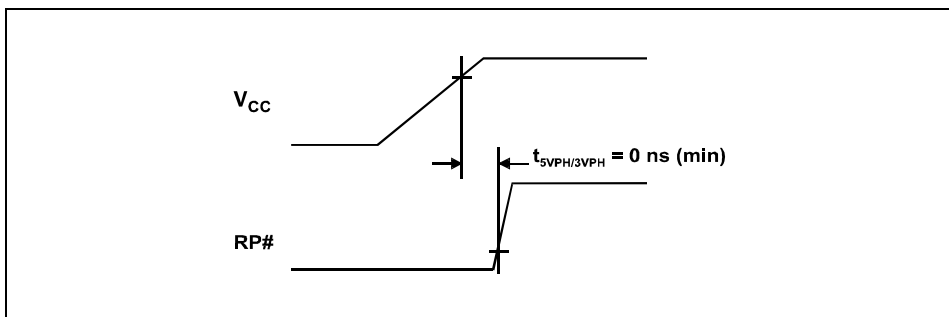
## 5. RP# Control during Power-Up

**PROBLEM:** RP# must be held low while  $V_{CC}$  ramps to a valid level during power transitions.

**Hold RP# Active While  $V_{CC}$  Ramps**

**IMPLICATION:** This erratum only affects power-up operations. Systems that tie the flash memory's RP# input to the system RESET# signal typically will not have a problem with erratum because the RESET# signal is usually held low during the power-up sequence to properly synchronize the CPU. However, systems that tie RP# directly to  $V_{CC}$  will be more exposed to this problem. So, carefully analyze RP# during the power-up condition to fully understand its behavior.

Use a simple RC delay network to hold RP# low during the power-up condition or tie the RP# input to the system RESET# signal. This workaround will eliminate your exposure to this problem and also provide your design with addition power-up security.
