21154 PCI-to-PCI Bridge

Specification Update

July 2004

Order Number: [278295-017](#)

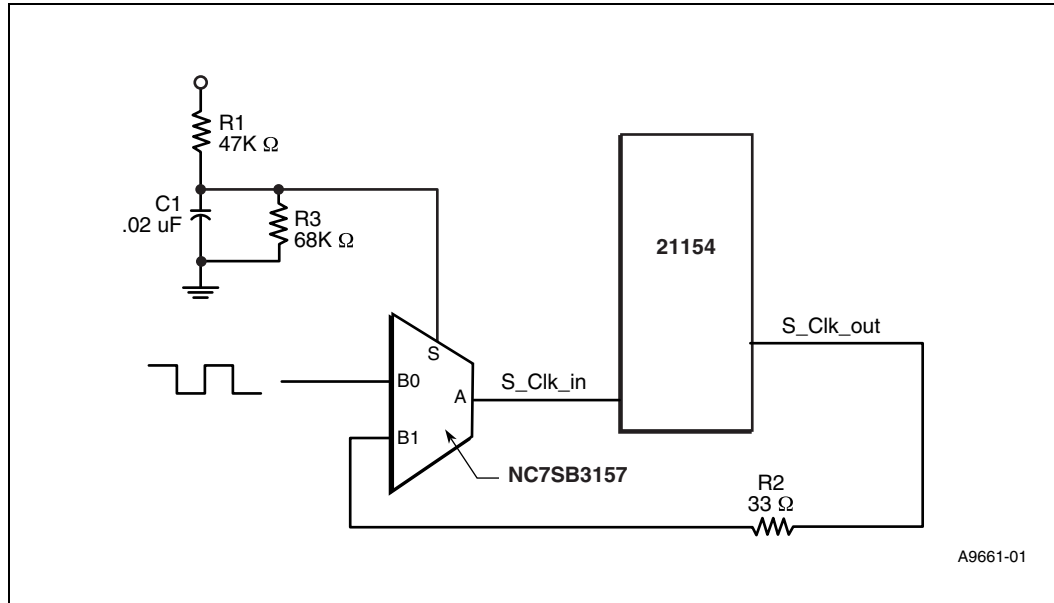
Figure 1. S_Clock Multiplexer Workaround Circuit for Errata 6.

6. Secondary Clocks Outputs s_clk_o<9:0> May Not Start-up Properly Under Some Conditions

Problem: This problem has been found on the 21154AC and 21154BC. Under repeated and frequent power cycling, the secondary clock circuits may not power up in the proper state, resulting in the device not coming out of reset after power up.

Implication: In a system with a 21154AC or 21154BC that has one of its s_clk_o<9:0> outputs fed back to provide the s_clk, it is possible that the s_clk_o<9:0> output clocks will be driven and remain low, keeping s_rst_l asserted, during system power up.

This happens occasionally when a latch whose output disables the serial shift registers on the Secondary clock control powers up in a high state and the shift register bit corresponding to the s_clk_o<9:0> output that is fed back also powers up in the high state.

1. [Figure 1](#) illustrates the first recommendation - a circuit where an on-board pulse source is gated via the B0 input of the multiplexer to the S_Clock_in pin of the 21150.

At time 0, the S input of the multiplexer is low, allowing pulses from the on-board pulse source, connected to the B0 input, to be provided to the 21150 S_Clk input pin. When the time determined by the R/C network is satisfied, the S input pin will be in a logic High state. The multiplexer will then shut off the input pulse from S0 and will direct the S_Clock_out pulses via the B1 multiplexer input, into S_Clock_in

The values used for the R/C network should be selected to allow a minimum of 2 pulses to be delivered to the 21150 after Vdd has reached 3.0V at a frequency not to exceed the appropriate PCI component. i.e. 30 ns for a 33Mhz bridge. These values should be chosen based on the rise time of the power supply and the frequency of the on board pulse source. The values given for R1, R3, and C1 are for example purposes only.

Note: The NC7SB3157 2:1 Multiplexer / Demultiplexer Bus Switch used in this example has a maximum propagation delay of 800ps that should be taken into consideration when matching trace lengths of the clock lines to avoid introducing excessive skew in the clocks. All S_Clock etch lengths must be matched to within 2ns @ 33Mhz or 1ns @ 66Mhz. The addition of this circuit requires that the etch length for the S_clock_in signal be reduced to compensate for the 800ps delay.
