21154 PCI-to-PCI Bridge

Specification Update

July 2004

Order Number: [278295-017](#)

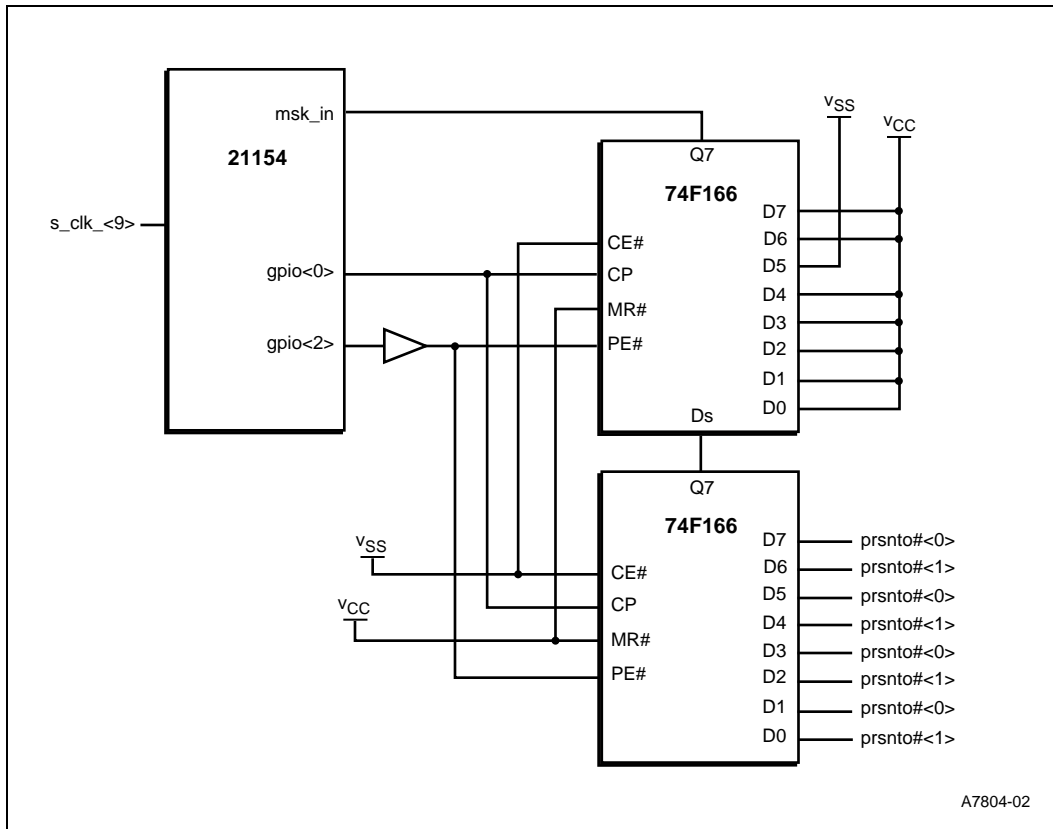
Figure 19 Example of GPIO Clock Mask Implementation on the System Board

12. Section 10.2, Secondary Clock Control, Figure 19

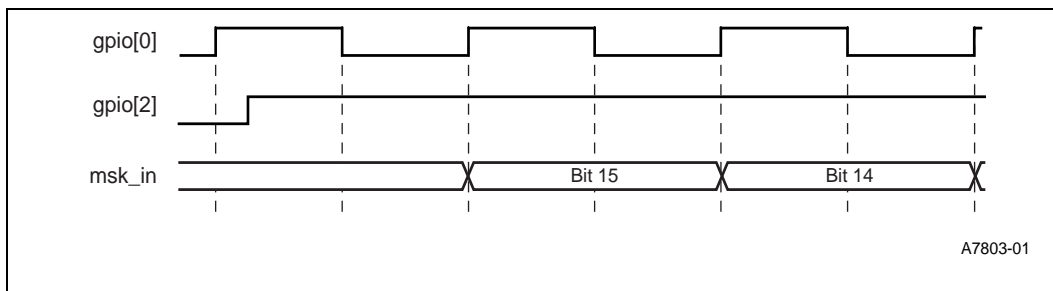
Figure 20. Clock Mask and Load Shift Timing

13. Section 10.2, Secondary Clock Control, Figure 20

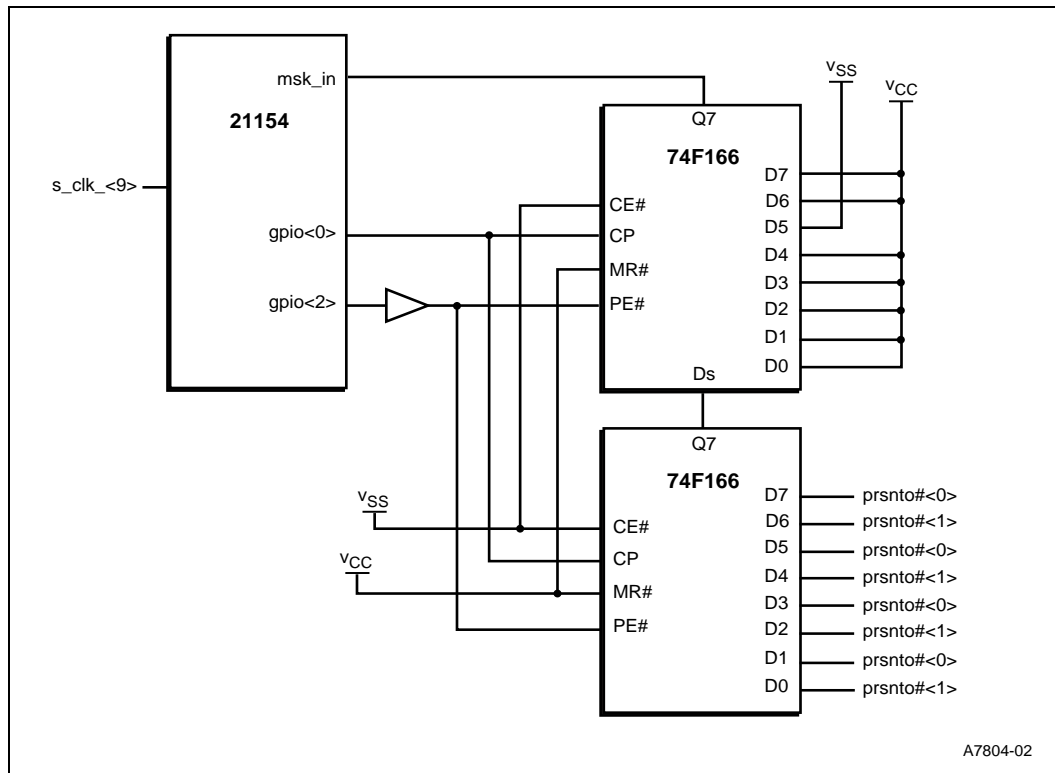
Figure 3 Example of GPIO Clock Mask Implementation on the System Board

18. Section 4.4.1, Serial Clock Mask Shift, Figure 3

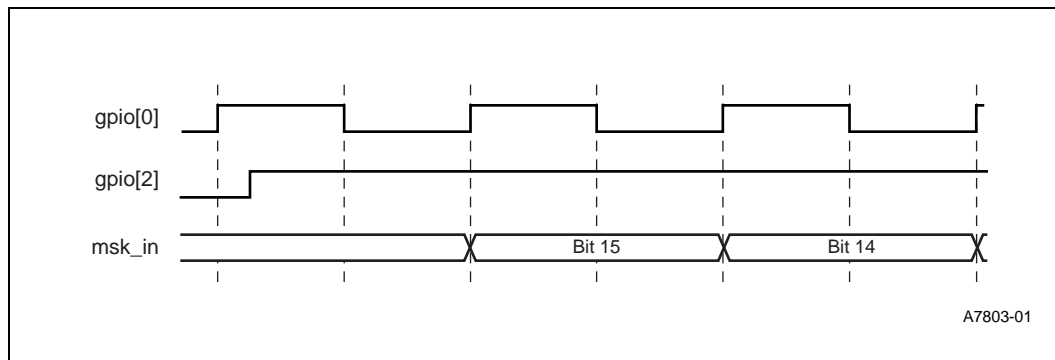
Figure 4. Clock Mask Load and Shift Timing

19. Section 4.4.1, Serial Clock Mask Shift, Figure 4
